Tech Tip

BRAKES 125

CHEVY TRUCK BRAKES Solving Pattern Complaints and Failures

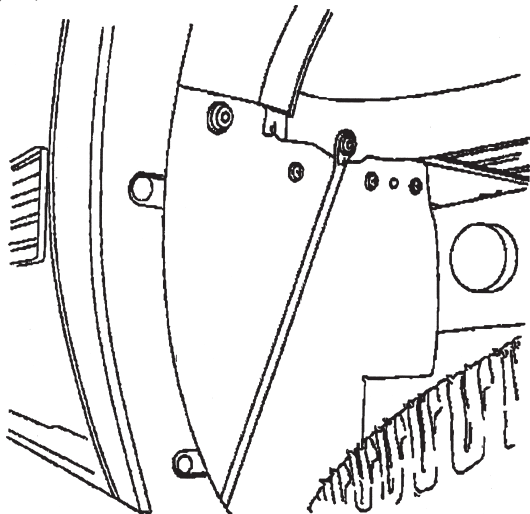
Fig. 1 Splash Shield Installed

Premature rear disc pad wear is not uncommon on 1999–2004 Chevy Silverado and GMC trucks. We hear the complaint often. In most cases the right rear pad is the first to encounter premature wear. The condition occurs on vehicles that have been used extensively off-road or in inclement weather conditions. Road debris or contaminants collect on the caliper and restrict caliper movement, promoting residual drag conditions and premature wear. The crown of the road/highway may contribute to the condition being more pronounced on the right side, as the water and debris would naturally accumulate on that side of the highway.

Minimizing the accumulation of debris on the rear calipers is the solution. GM recommends installing mud flaps (splash shields) P/N 15765007 forward of each rear wheel. When installed, the splash shields are positioned forward of the bed panel braces (see Fig. 1)

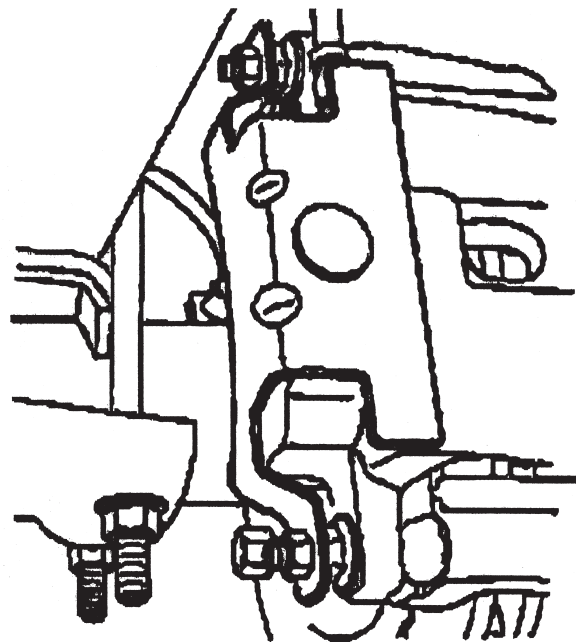
Fig. 2 Rear Caliper Shield

Customer complaints of a low brake pedal condition, the red brake lamp illuminated, and the brake system warning message on, may be due to a loose

caliper banjo bolt. If the vehicle is used in extreme off-road conditions, debris may make contact with the brake hose and loosen the caliper banjo bolts, resulting in a brake fluid leak. A farm vehicle or a teenage driver who does a lot of 4-wheeling are two good examples of extreme service. Most GM trucks from 2000–2004, in addition to Suburban, Avalanche and Yukon XL may be affected.

Inspect the rear calipers for evidence of fluid leakage. If a leak is present, the banjo bolt copper gaskets should be replaced and the caliper thoroughly cleaned. To prevent a reoccurrence, GM recommends installing a shield kit (P/N 15188166) on each rear caliper to prevent debris from making contact with the brake hose and banjo bolt (see Fig. 2). Included in the kit are two new caliper guide pin bolts and attaching nuts, necessary to secure the protective shield to the caliper.
