Tech Tip

IGNITION 127

PATTERN FAILURES Plagued with Problems by Design

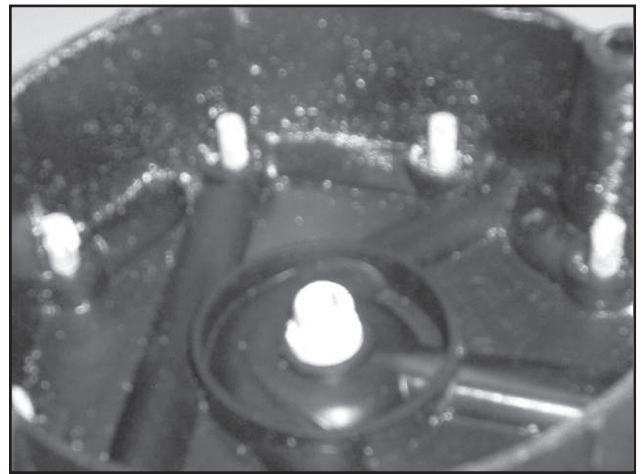
The aforementioned ignition system has encountered excessive levels of distributor cap corrosion, resulting in internal arcing and misfiring. Many technicians are of the opinion that the type of metal used in the construction of the terminals is the reason for the heavy concentrations of deposits and misfire conditions. This is not the case. GM has acknowledged what we have suspected all along, that the corrosion condition and the heavy deposit formation is the result of *inadequate ventilation* in the distributor housing. The gases collect in the distributor cap and housing, and in the presence of heat and high voltage, form corrosive deposits, resulting in internal arcing and misfire conditions. When these conditions are present, the cap and rotor will usually reflect the

presence of a white or tan residue on the inner walls of the cap and rotor, and the terminals will be encrusted (see illustration 1). The contaminants are conductive and can promote a misfire condition, resulting in misfire codes being stored in the diagnostic memory.

ILLUSTRATION 1:
LIGHT CORROSION DUE TO POOR VENTILATION

Inspect the base of the distributor and the distributor shaft for the presence of rust. While the distributor housing is made of plastic, you are looking for an accumulation of debris from other internal metal components. Components that are affected by corrosion should be replaced. The accumulation of debris in the distributor housing can restrict the ventilation screens. Most technicians are not aware that this style distributor is fitted with vent screens, as the distributors on these applications seldom have to be pulled for service, with the exception of replacing the intake manifold gaskets. The vents are positioned at the base of the distributor and are almost impossible to see with the distributor mounted in the engine (see illustration 2). In fact, the screens are easily missed while viewing the distributor on a work bench. The two vent screens are approximately the diameter of a pencil eraser and they are easily plugged when debris is present. The frequency in which they plug increases with vehicle mileage. Naturally, as the engine wears, the blow-by gases increase, thus an increase in the gases collected in the distributor housing. A malfunc-

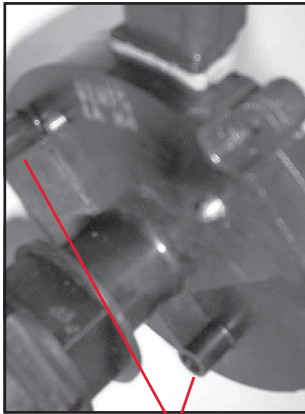
Vent Tubes

ILLUSTRATION 2:
SCREENS ARE POSITIONED
AT DISTRIBUTOR BASE

tion in the PCV system can produce the same results. The vent screens should be washed with a solvent, such as brake clean, and any contamination expelled with air pressure. Wear safety glasses to prevent an eye injury. These conditions have prompted GM to release two revised distributors that incorporate larger air-flow screens for improved ventilation. GM recognizes 2001–2003

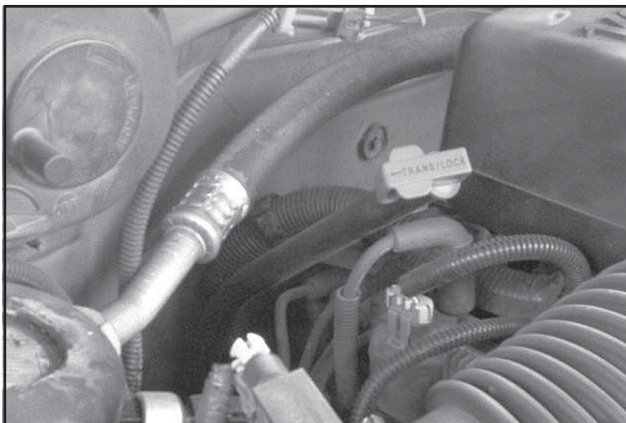
ILLUSTRATION 3:
A/C ACCUMULATION LINE DRIPS WATER ONTO CAP

applications, the A/C accumulator line is routed directly over the distributor cap (see illustration 3). The condensation from the line drips directly onto the distributor cap and housing. If you identify this condition, installing a foam sleeve over the accumulator line can minimize the moisture problem. Water dripping on a hot distributor cap can promote electrical tracking and arcing.
