## ENGINE NOISES

### Normal Characteristic or a Catastrophic Event?

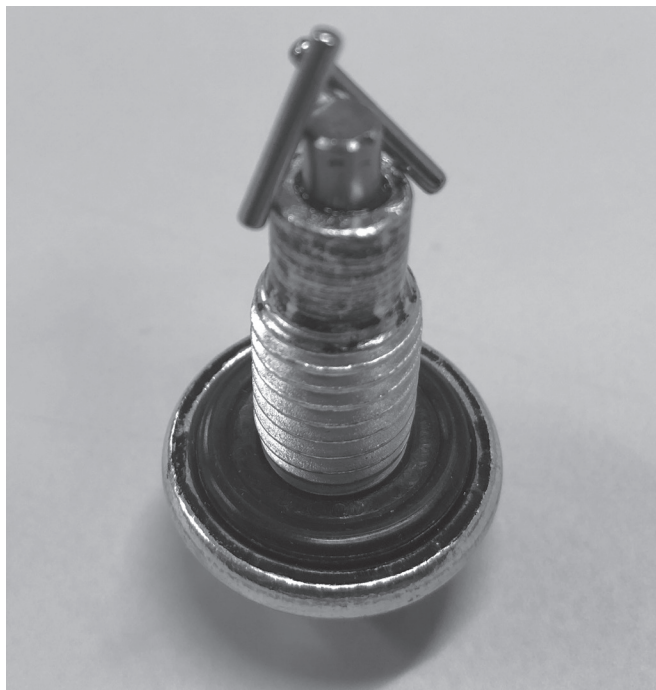
Fig. 1

A simple oil and filter change results in the technician recommending some major engine repairs. While performing a lube service the technician observes needle bearings attached to the magnetic oil drain plug (see Fig.1). This is not a location that we would expect to find needle bearings.

Needle bearings in the oil pan has become a frequent occurrence on GM applications with push rod engines equipped with roller rocker arms and roller valve lifters. Vehicles affected include V6 and V8 engines produced from 2000 to 2021.

Removing the needle bearings and continuing with the oil change is not an option. The customer should be notified immediately, as the removal of some engine components will be necessary to retrieve additional needle bearings and possibly prevent engine damage.

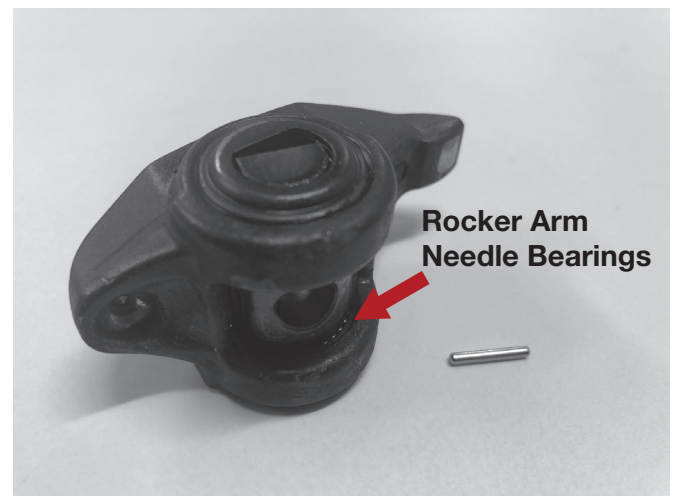
Fig. 2

While the needle bearings are usually first observed in the oil pan, they may also be found in the cylinder head oil return ports, making a visual inspection of that area mandatory. GM states that the needle bearings are larger than the mesh screen on the oil pump pickup; therefore they cannot be pulled into the oil pump. However, a concern is the small fragments of metal that may be ground up during the rocker arm failure could be an issue resulting in engine damage. Many of the needle bearings attached to the oil drain plug are only fragments of the bearings. Each rocker arm contains 66 needle bearings (33 per side). The needle bearings are approximately 1/4 inch in length (see Fig.2). When needle bearings are present, a thorough inspection of all rocker arms should be performed.

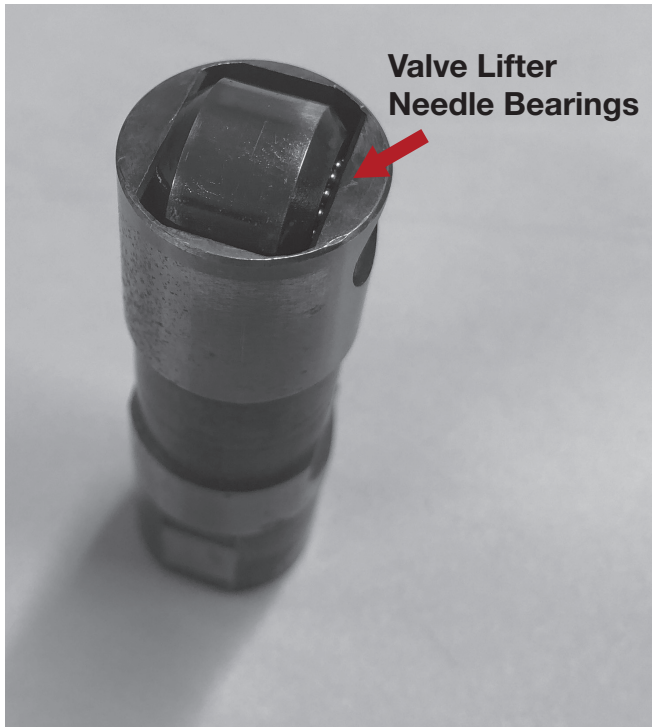
**Fig. 3**

Needle bearings that measure approximately ½ inch in length have also been reported attached to the oil drain plug when performing a lube service. Needle bearings of this length could only originate from the valve lifter rollers (see Fig.3).

Needle bearings found in the oil pan or cylinder head oil return ports could only originate from the two mentioned locations. Any evidence of these bearings should warrant a full inspection of the rocker arms and/or valve lifter rollers. The needle bearing length should determine which component is at fault, assuming the needle bearing is fully intact and not ground into fragments.
