## **ELECTRICAL INTERFERENCE**

### **Diagnosing Radio Frequency Interference Symptoms**

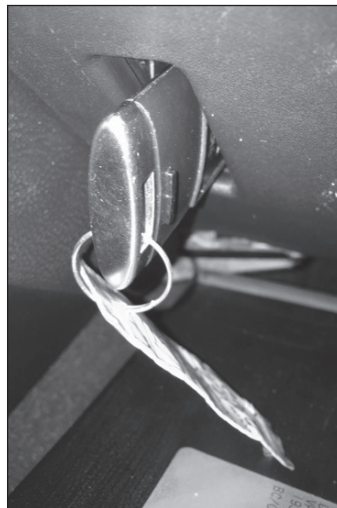
**FIG. 1**

When the message and symptom appear, the vehicle can usually be started by placing the fob in a special slot/pocket, which is in close proximity to one of multiple antennas, which improves the signal strength. For example, Fig. 1 reflects the special slot/pocket located in the glove box of a Corvette. On some vehicles the slot may be located in the center console or a cavity within the dash.

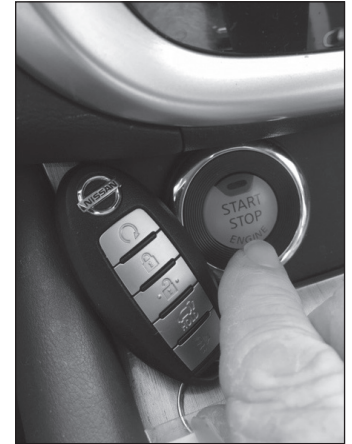
**FIG. 2**

Nissan's procedure calls for positioning the fob next to the Start/Stop button, while at the same time depressing the button to achieve the same increased signal strength (see Fig. 2). Some procedures call for depressing the start button with the tip of the key fob.

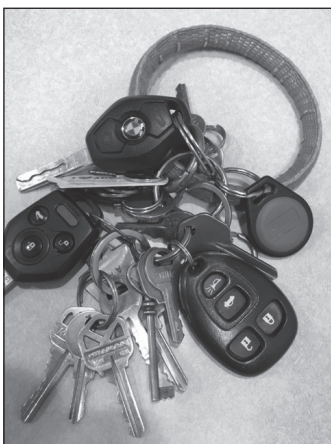
**FIG. 3**

Be cautious of attaching multiple transmitters/fobs on a single key ring as RFI-related symptoms can occur.

Consider the key ring illustrated in Fig. 3. This key ring could create a myriad of RFI-related performance issues that would challenge the best technician.
